State of Oregon
Department of Environmental Quality Memorandum

Subject: Schnitzer Investment Corp. Doane Lake Property File ECSI #395
Proposed Source Control Decision-Determination that Source Control Measure
Satisfactorily Performed.

Attachment A
**Doane Lake Cap Inspection Report
Photograph Log**

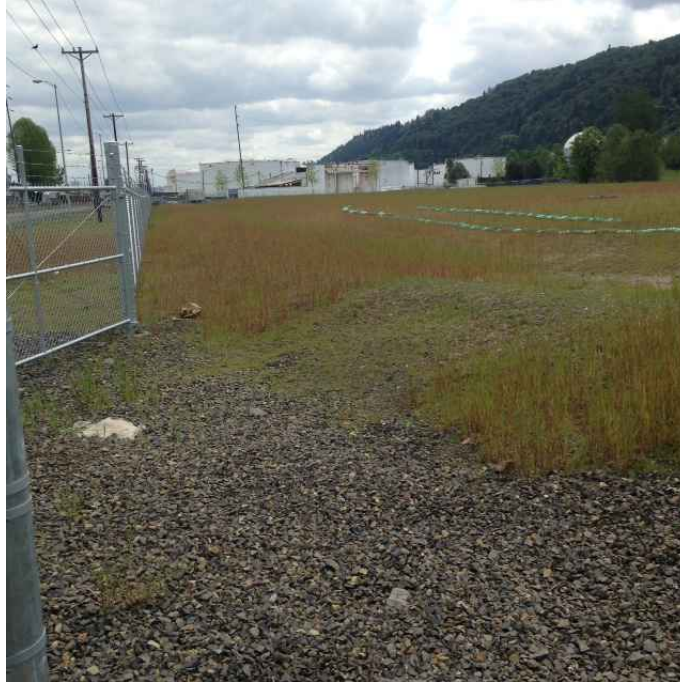
Doane Lake May 4, 2015. Northeast corner near gate. Sand bags installed December 2015 to minimize erosion.

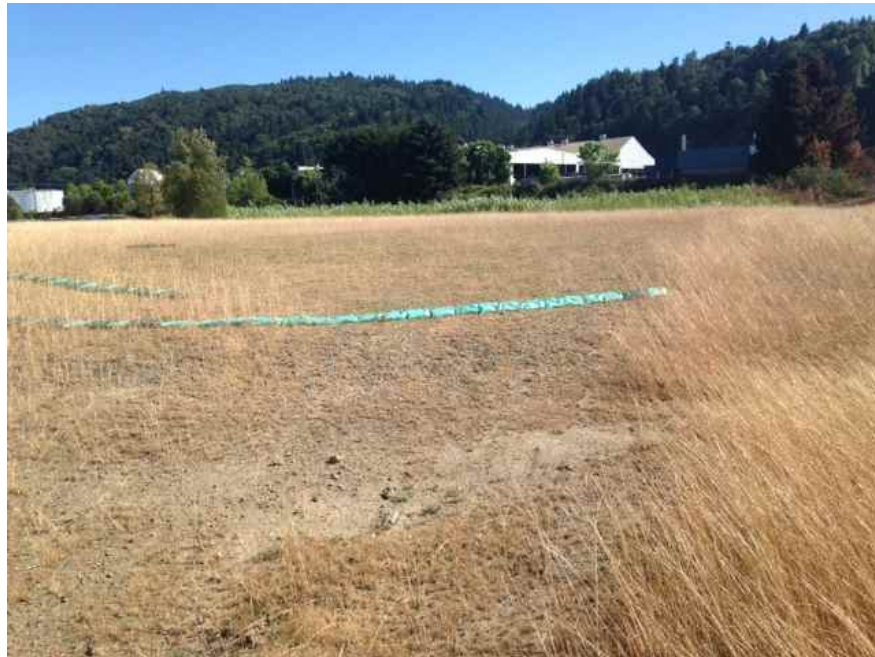
Doane Lake June 30, 2015. Northeast corner of cap area.

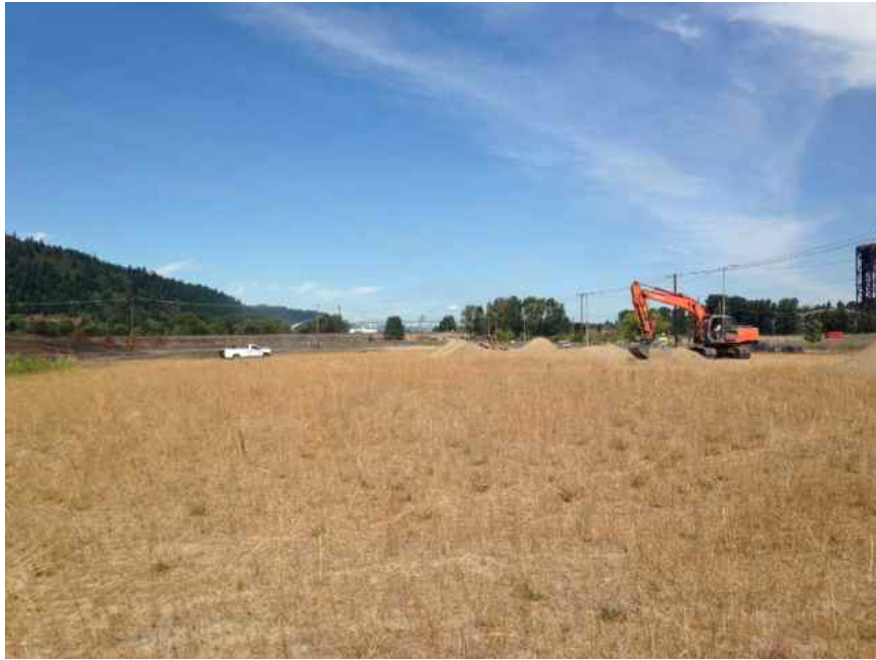
Doane Lake August 9, 2015. Cap augmentation work northeast corner. Stripping topsoil.

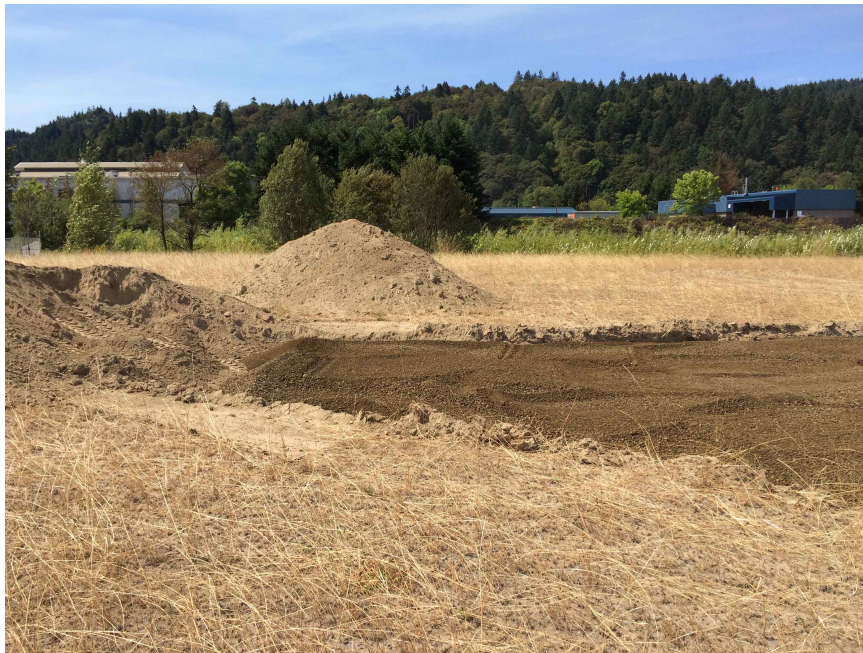
Doane Lake August 9, 2015. Cap augmentation work. Quarry material placed.

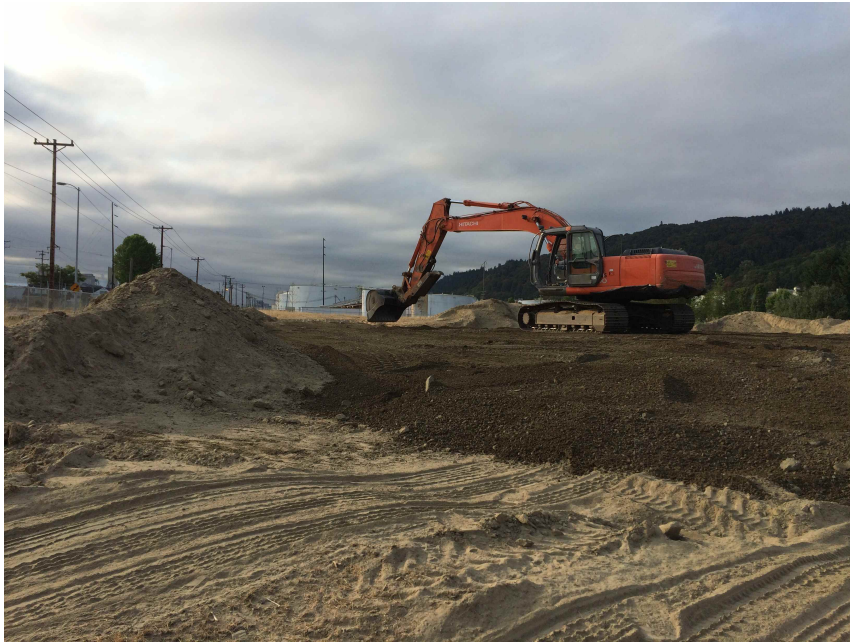
Doane Lake August 10, 2015. Cap augmentation work, northeast corner near gate. Graded quarry material.

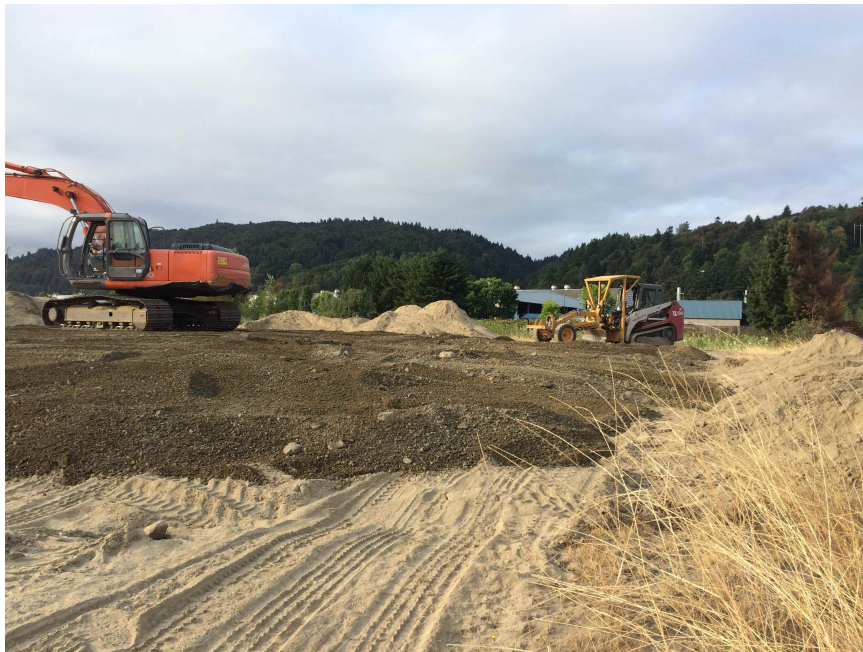
Doane Lake August 10, 2015. Cap augmentation northeast corner. Grading quarry material.

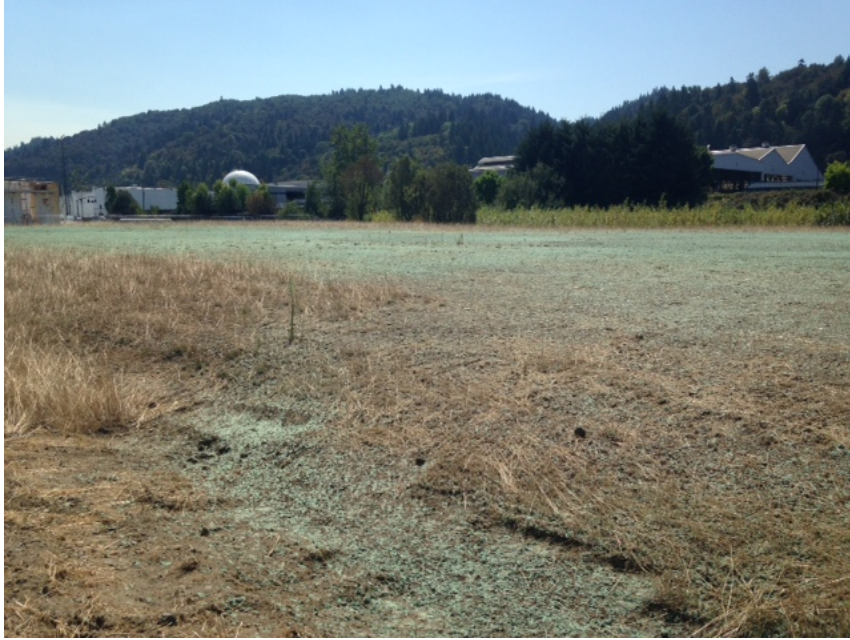
Doane Lake August 18, 2015. Post cap augmentation, graded, compacted, and hydroseeded. Northeast corner near gate, looking southwest across Site.

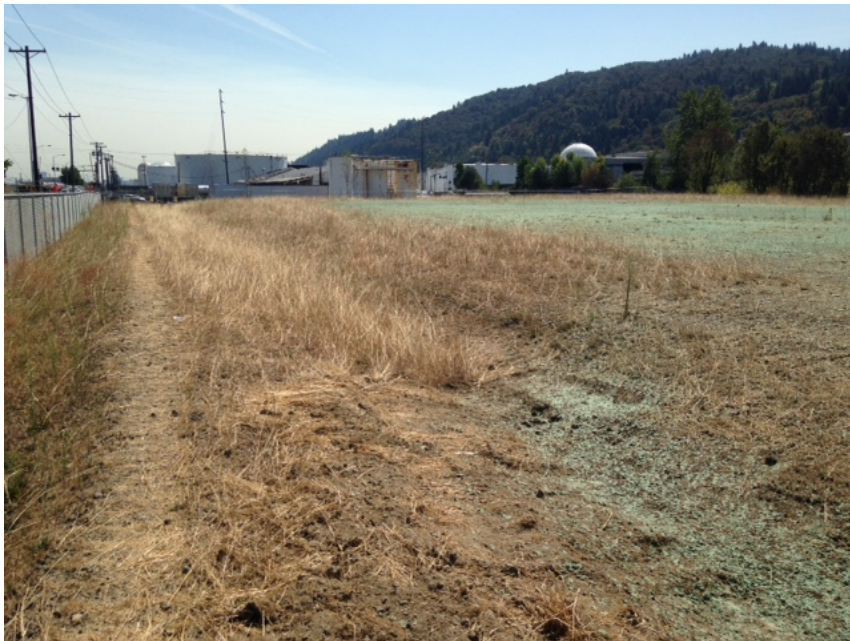
Doane Lake August 18, 2015. Post cap augmentation, graded, compacted, and hydroseeded. Northeast corner near gate, looking south along east swale.

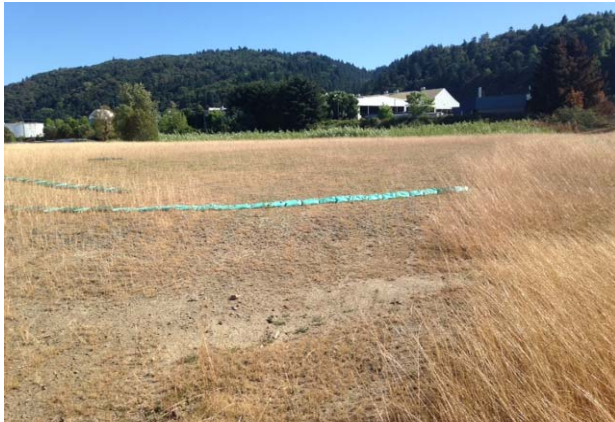
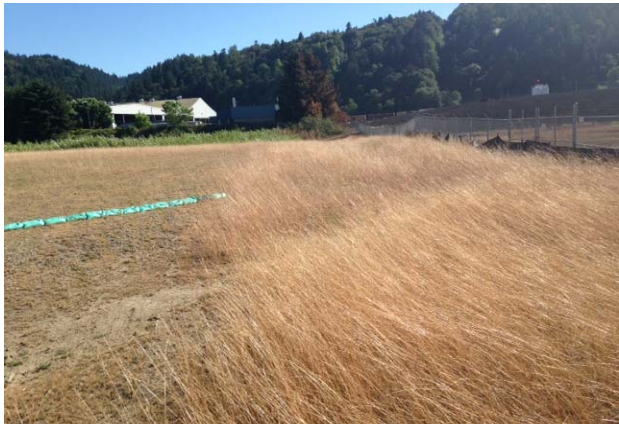
Please note, the adjacent site to the northwest had caught on fire the weekend prior.
 Very little impact was done to the property however some grass was burned along the fence line.

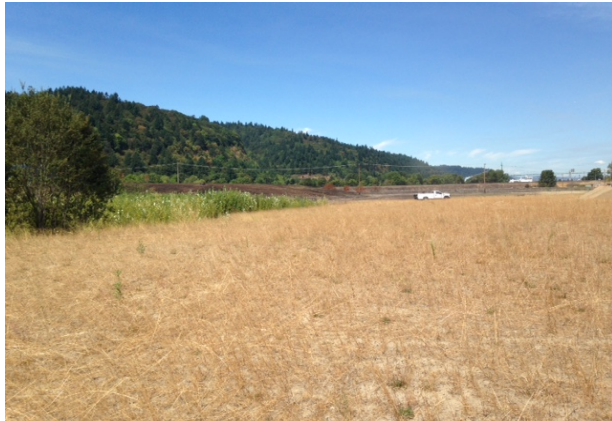
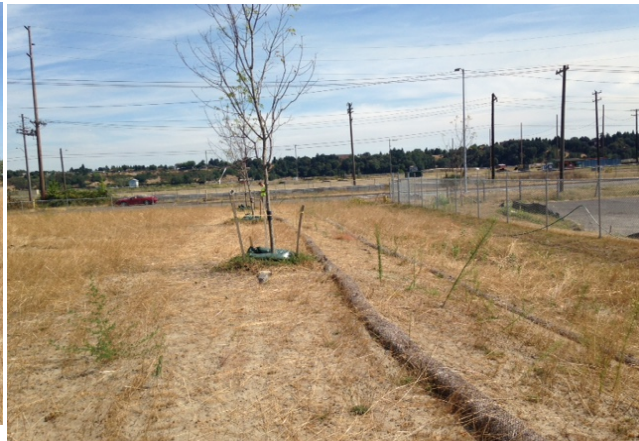
Construction taking place today and tomorrow for fixing eroded areas. See pictures below. No precipitation.

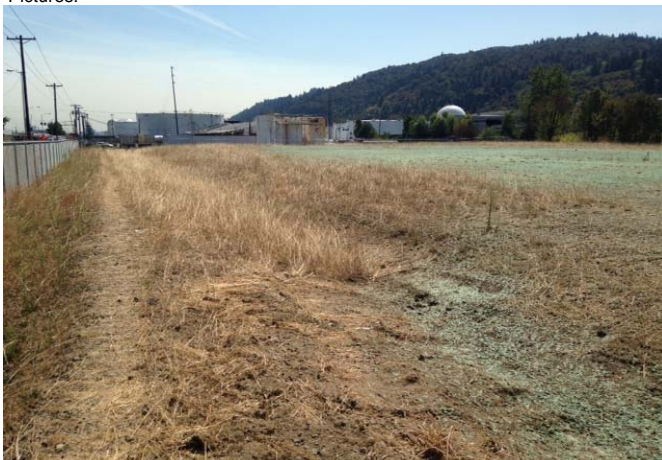
Grass seeding taking place today
